①
UNDERWATER FACILITIES
INSPECTIONS
AND
ASSESSMENTS
AT

NAVAL EDUCATION
AND TRAINING CENTER
NEWPORT , R.I.

MAY 1981 FPO-1-81 (10)

CHILDS ENGINEERING CORPORATION
MEDFIELD, MASSACHUSETTS 02052

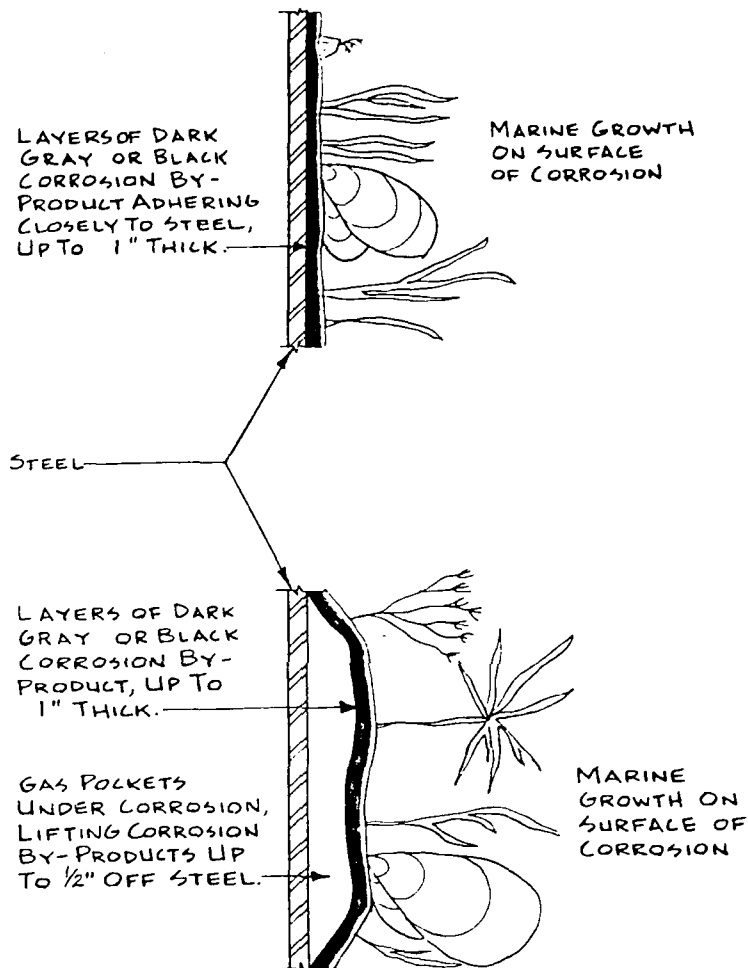
GRAPHIC SCALE	CHILDS ENGINEERING CORPORATION BOX 333 MEDFIELD, MA	CHESAPEAKE DIVISION NAVAL FACILITIES ENGINEERING COMMAND WASHINGTON D C	NETC NEWPORT, RI	FIG NO.
N/A		TYPICAL CORROSION BUILDUP		5

On the submerged portions of all the steel piles, deposits of black corrosion by-product with gas pockets trapped beneath were common. At both facilities, this corrosion buildup was heavy, sometimes up to 1" thick. An example of this type of corrosion is illustrated in Figure 5. Under the corrosion buildup, the metal of the steel pipe piles at Pier 2 was basically smooth and unpitted. The metal of the steel H-piles of the quaywall apron, however, was heavily pitted, with pits reaching 1" in diameter and 1/8" in depth.

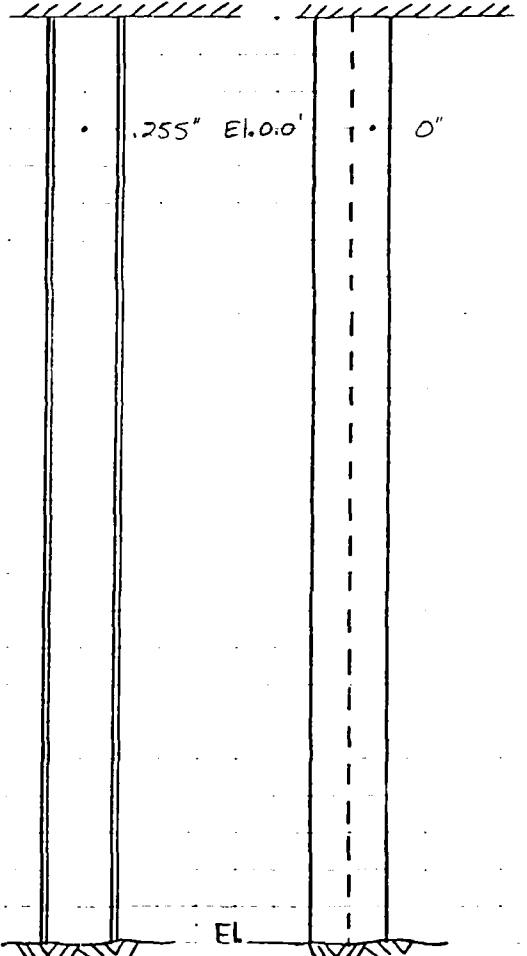
BENT 51 PILE E
PILE TYPE HP 12 X 53

ORIGINAL THICKNESS: .436" ORIGINAL THICKNESS: .436"
WEB FLANGE

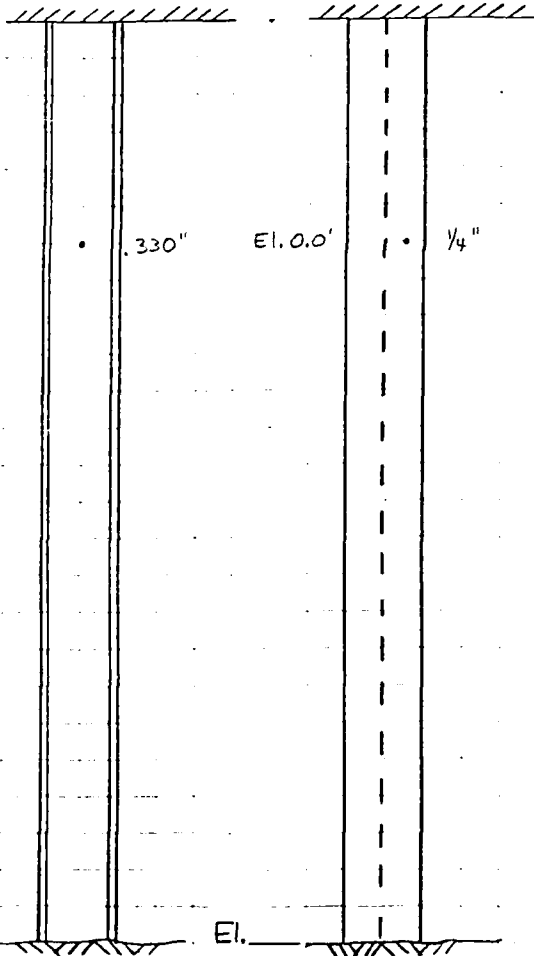
BENT 54 PILE D
PILE TYPE HP 12x53

ORIGINAL THICKNESS: .436"
WEB ORIGINAL THICKNESS: .436"
FLANGE

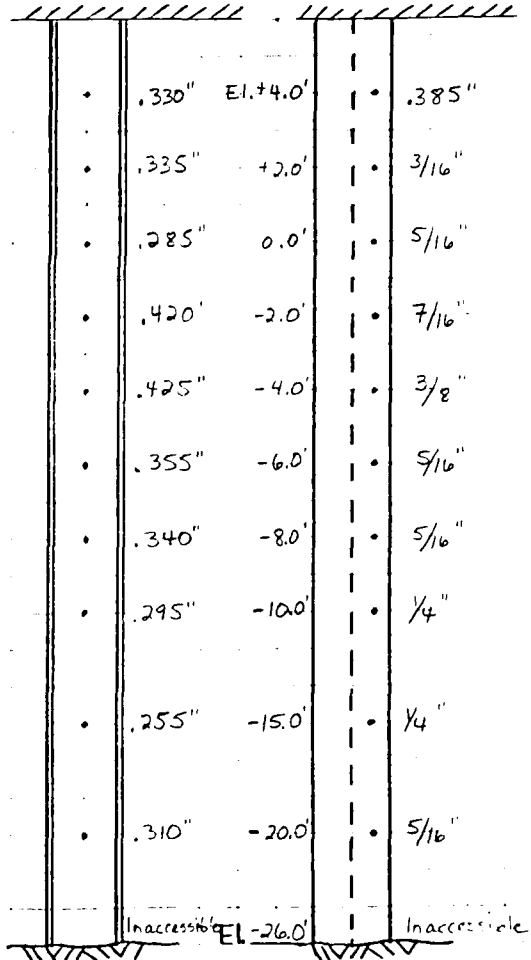
BENT 57 PILE C
PILE TYPE HP 12x53

ORIGINAL THICKNESS: .436"
WEB ORIGINAL THICKNESS: .436"
FLANGE

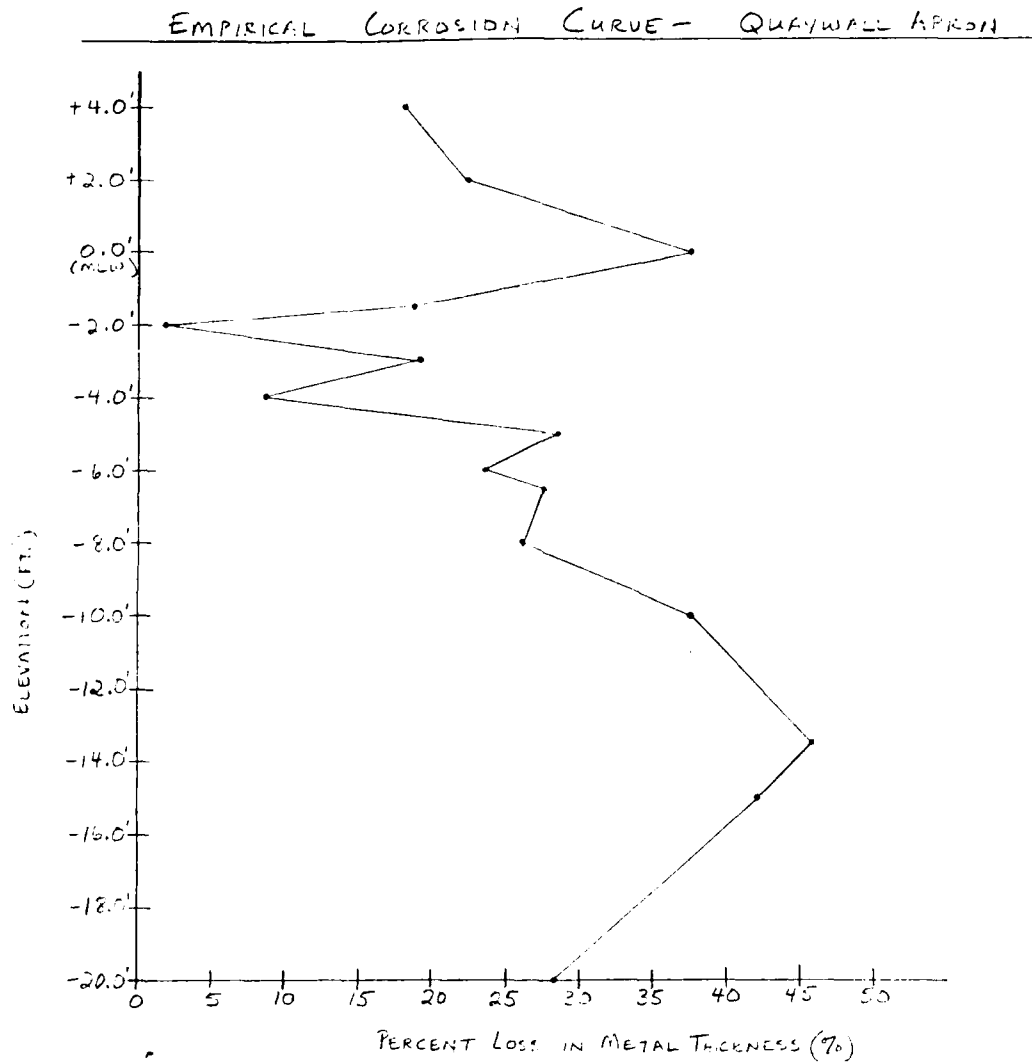
Note: Percent Metal Loss is derived from thickness readings taken on Pile D of Bunt 33 and Pile C of Bunt 57 and averaged over each elevation (ie, some percentages are averages of 2 readings (web + flange on one pile) and some are averages of 4 readings).
